Technical Bulletin 106

4012 Rear Paint Damage

Date: 20/12/2022

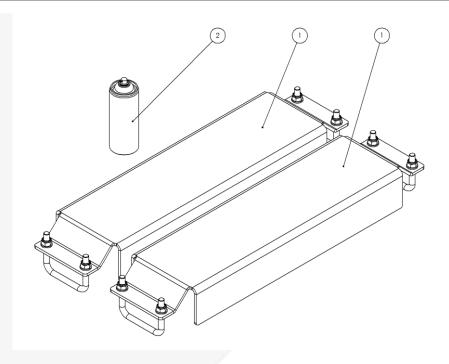
Figure 1 - 0510-0022

Overview: Kelly is always seeking to improve its machines and designs in collaboration with our customers. Commencing June 2023 all new Model 4012 machines will be shipped with rear 'A Frame' (1540-03-3) guards. See item 2 figure 1 below. It has become evident that in some situation's discs contact the rear 'A Frame' causing damage. The provided parts will repair and prevent this issue from occurring on your machine.

ITEM NO.	PART NUMBER	DESCRIPTION	QTY.
1	1510-650A	Guard Assembly	2
2	0451-GLOSSGREEN	Kelly Green Aersol Paint Can 350G	1
