Technical Bulletin 037

Model 46 Walking Axle Hyper-extension

This technical bulletin relates to Model 46 machines built before January 2018.

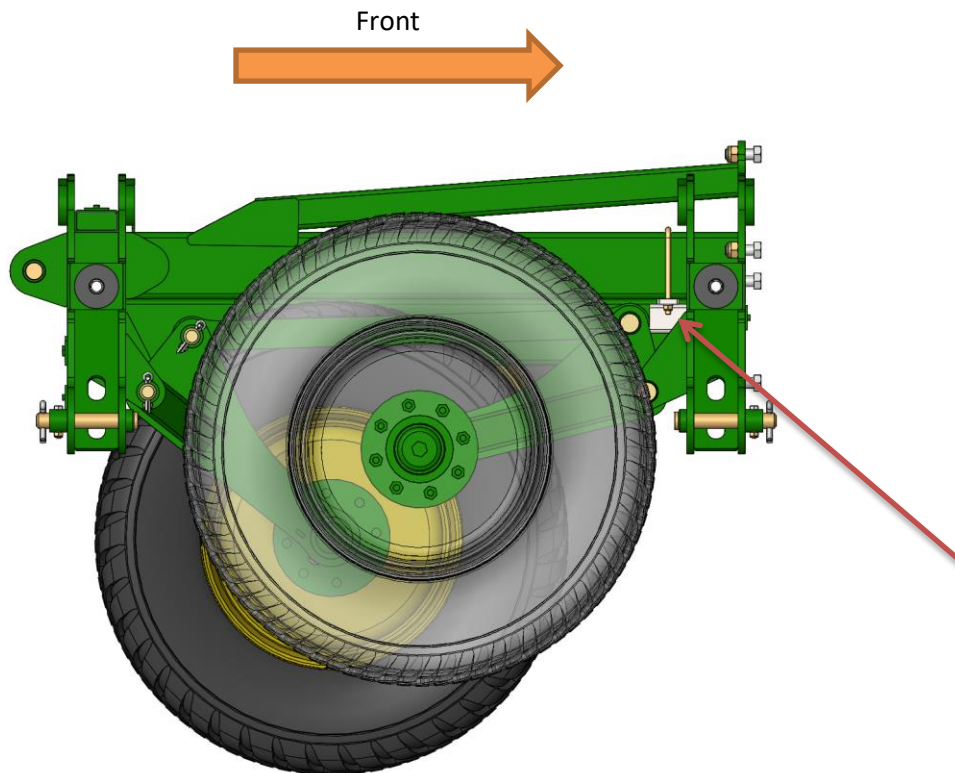
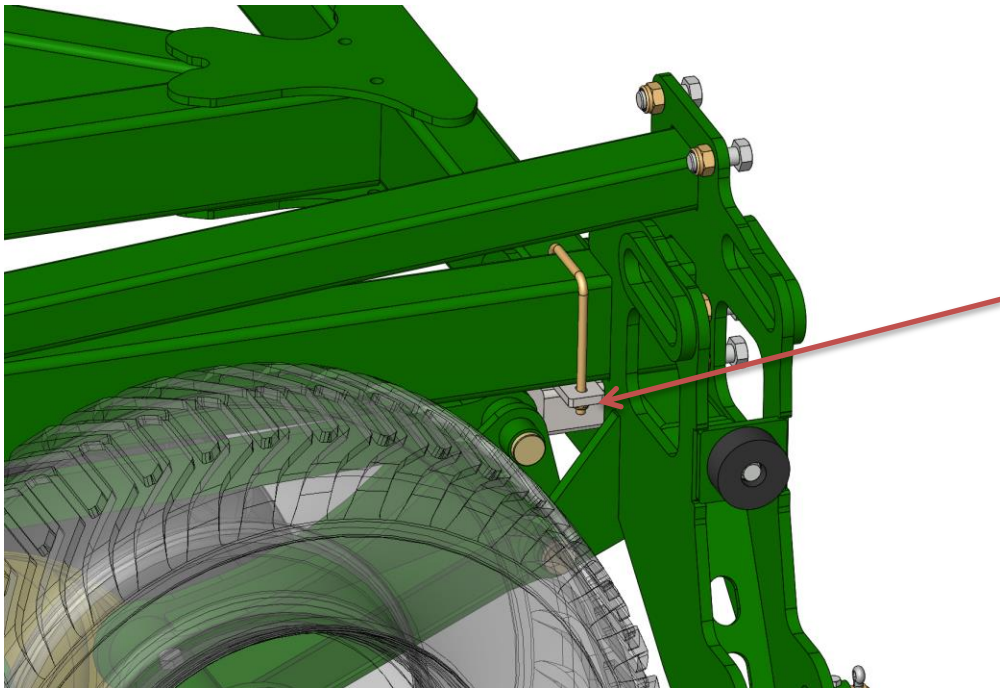
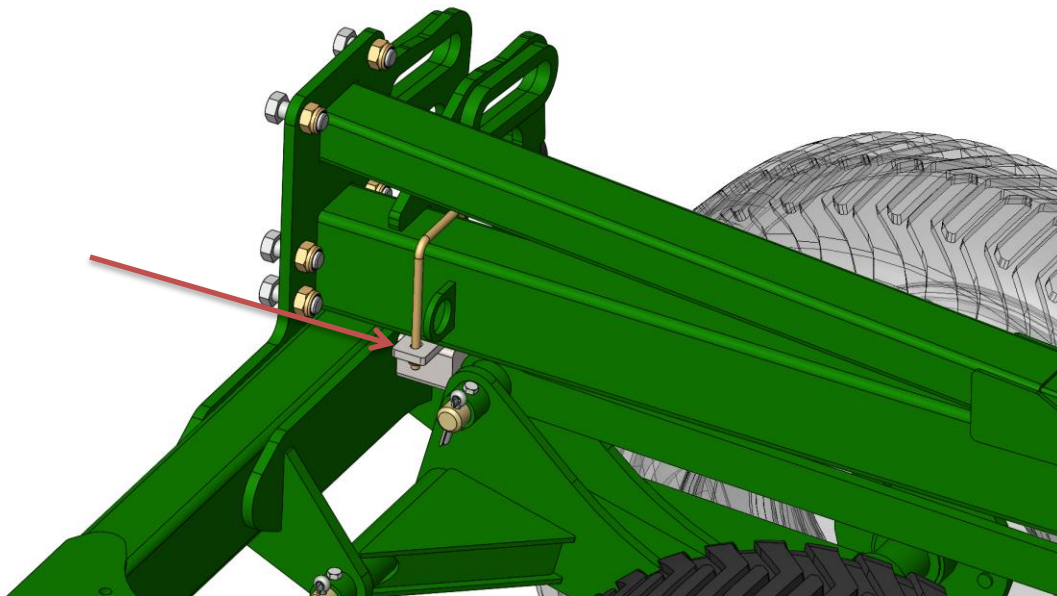
Under certain conditions it is possible for the rear walking axle to travel down too far resulting in the axle going over center in its travel.

The following outlines the steps required to prevent this from happening using the supplied parts:

U-bolt the supplied block as shown on the front of the center frame on both sides, this will limit the travel of the walking axle preventing hyper-extension.
