Field Finish Adjustment

KEPRES001

Revision B

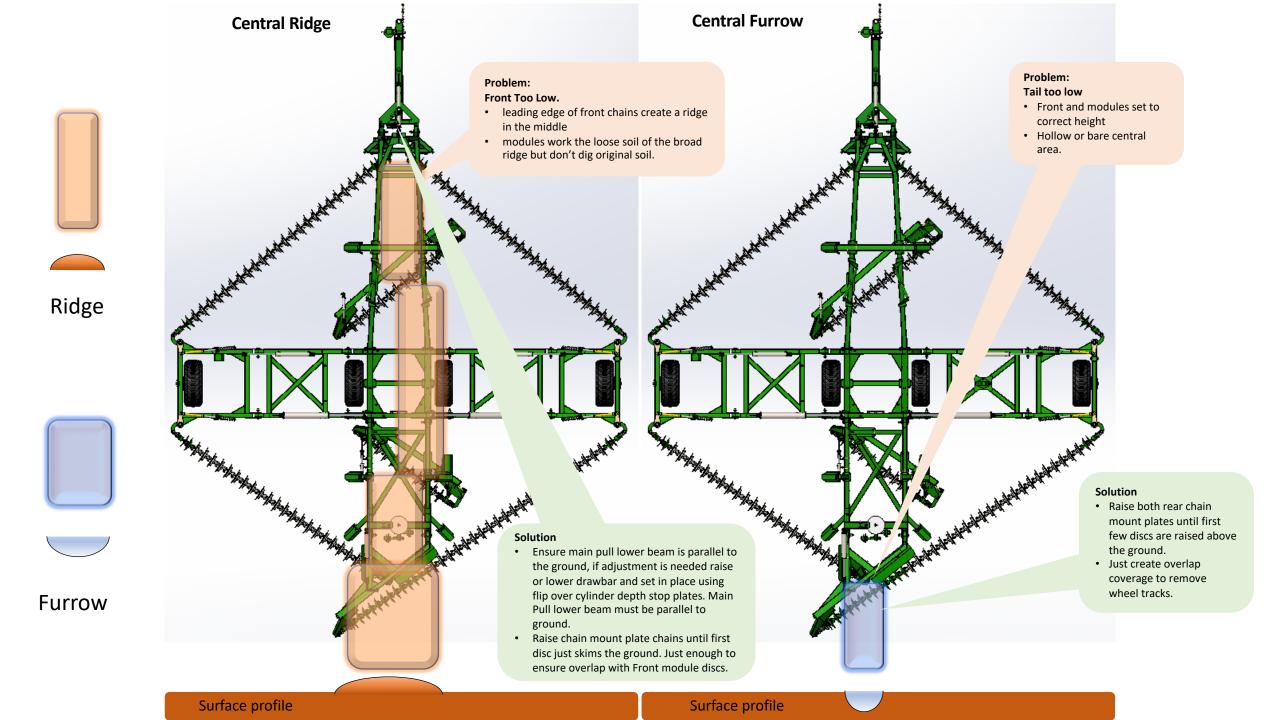
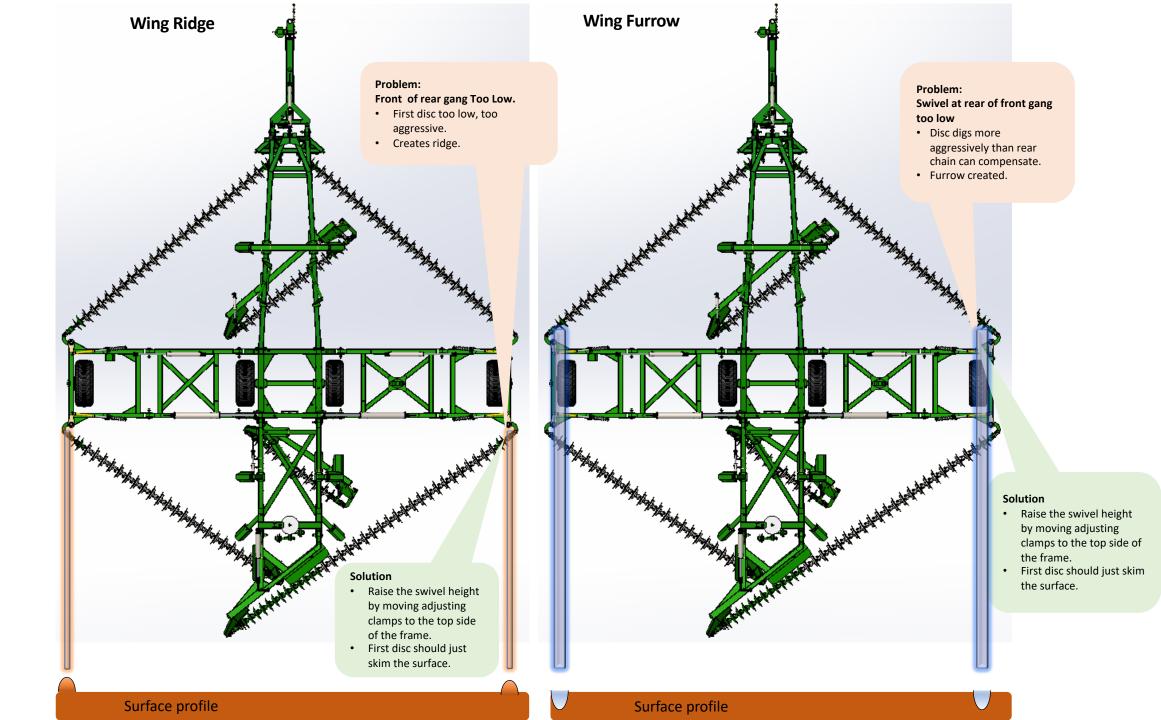
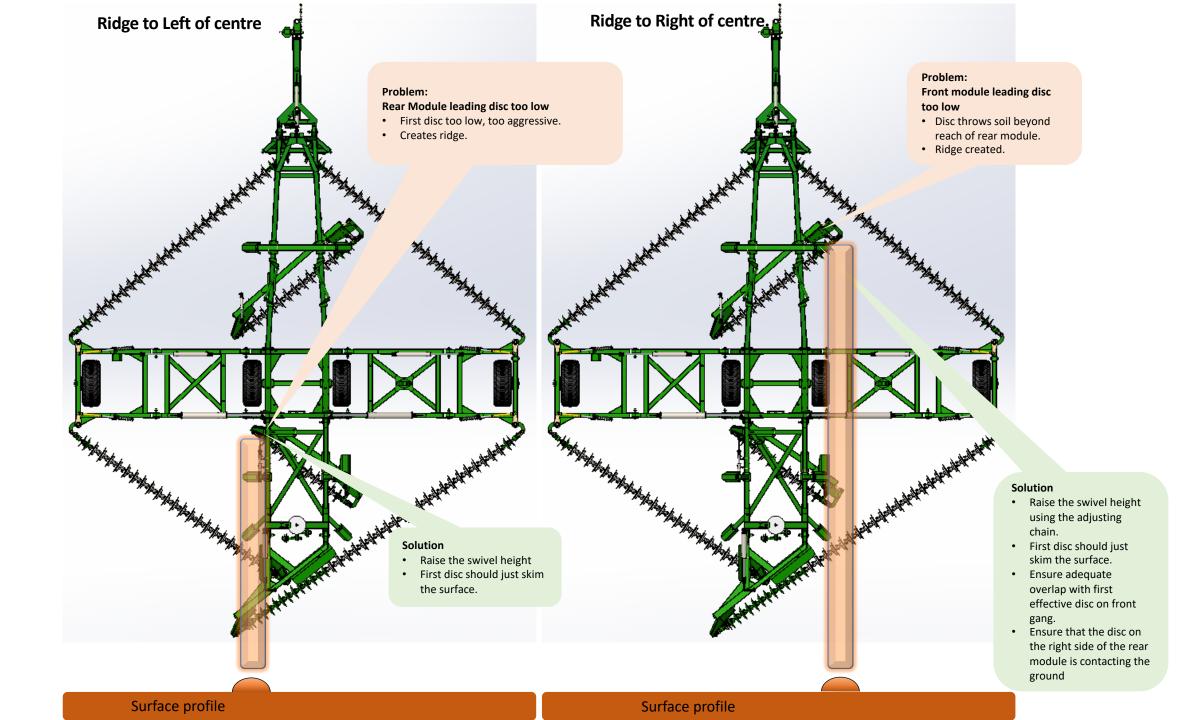
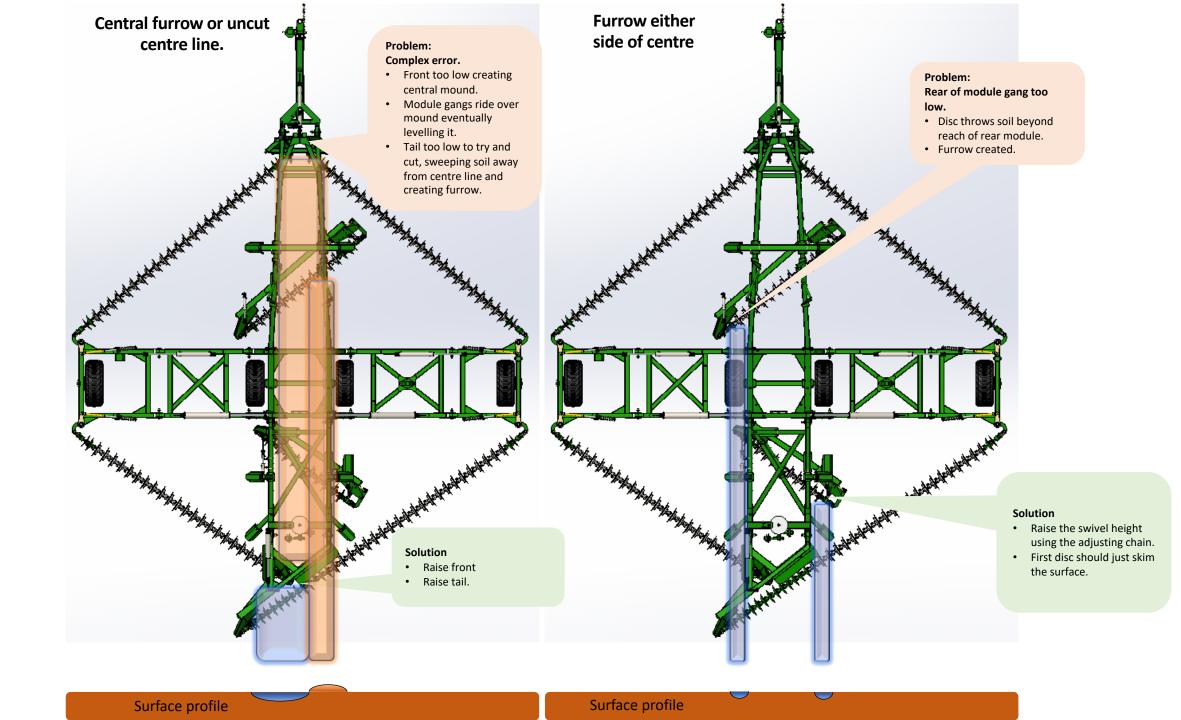
See operator's manual for detail on height adjustments. These slides are intended to help troubleshoot uneven field finish. In principal, if there is a ridge created, the leading disc in line with that ridge is the culprit. For furrows, the trailing disc in line with the furrow will be the culprit. Almost always the solution is to raise the swivel at that point.
